Broadway Lofts Parking Garage

SAN ANTONIO, TEXAS

SUBMITTED BY MIRACOTE DIVISION OF CROSSFIELD PRODUCTS

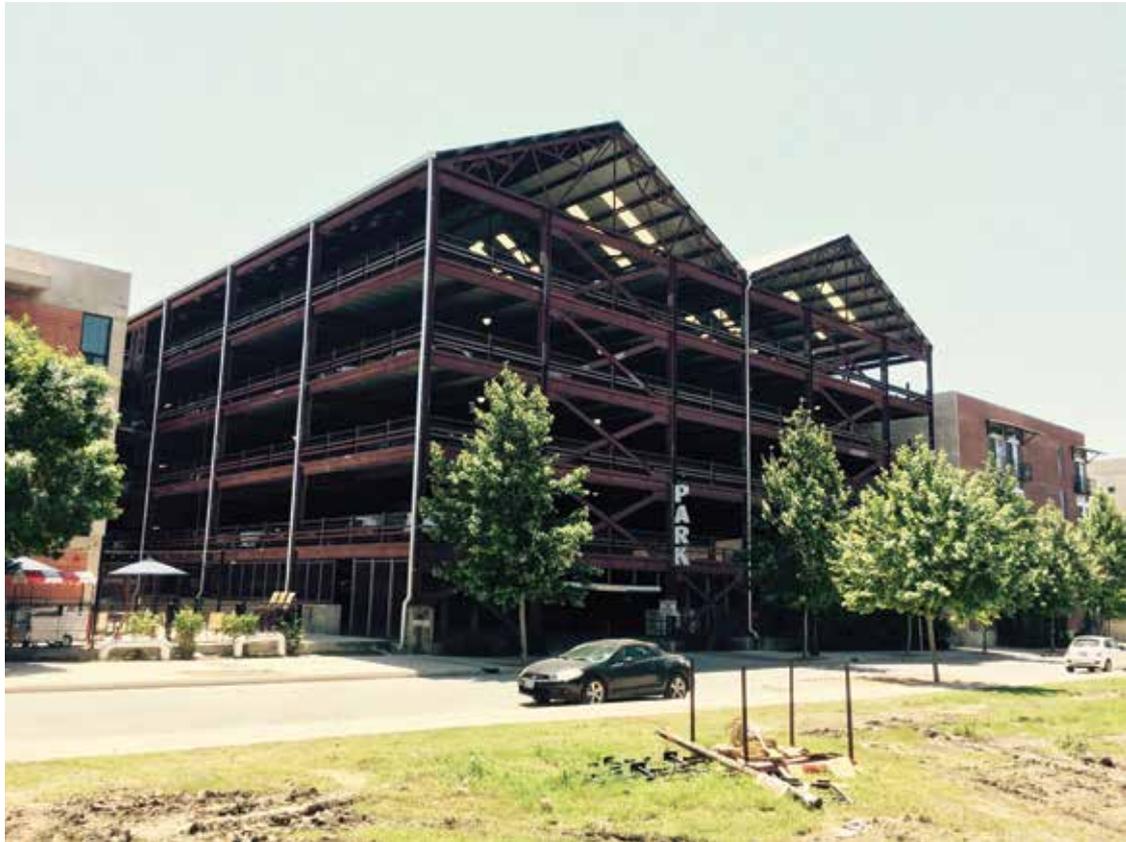
Broadway Lofts before Rehabilitation

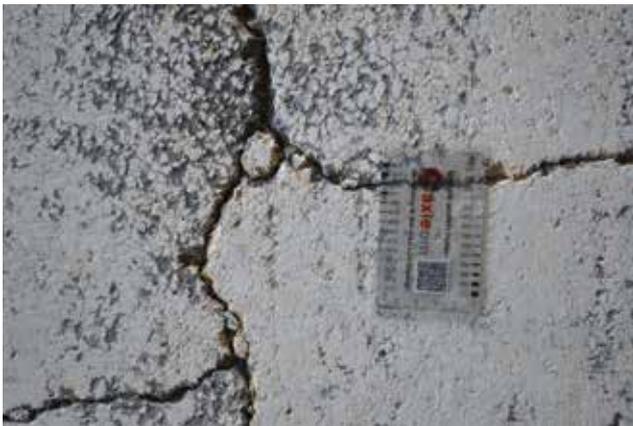
Crack Measured with Mil Gauge

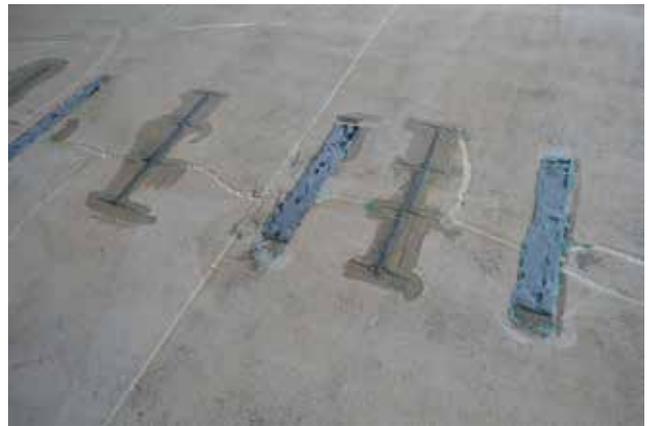
Carbon Fiber Strapping and Stapling Repair

- Ultra-low viscosity menders custom-formulated for the project were used to rebond slab sections so that the slab functioned as a monolithic unit;
- Deep-penetrating hardeners were employed to achieve appropriate concrete strength and stabilize pH parameters;
- A system of custom-designed carbon fiber staples alternating with custom-designed,

rigid, open-grid carbon fiber strips were embedded to achieve the appropriate slab tension and to stop deflection; and

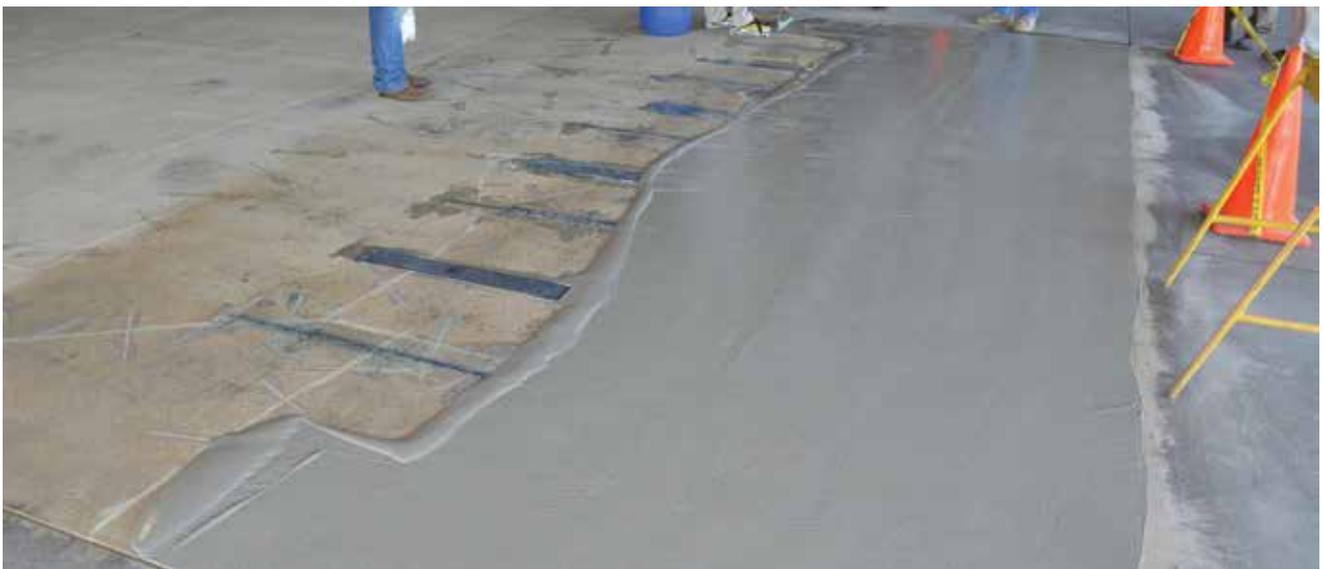
Cementitious Overlay Installation Over Strapping and Stapling Repair

- A time-tested, heavy-duty overlay system was installed to create a durable and attractive traffic-bearing surface.

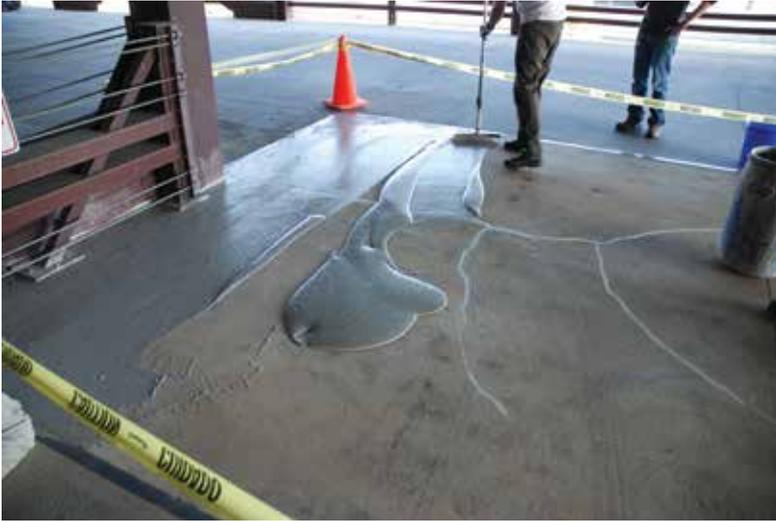
Applying Cementitious Overlay

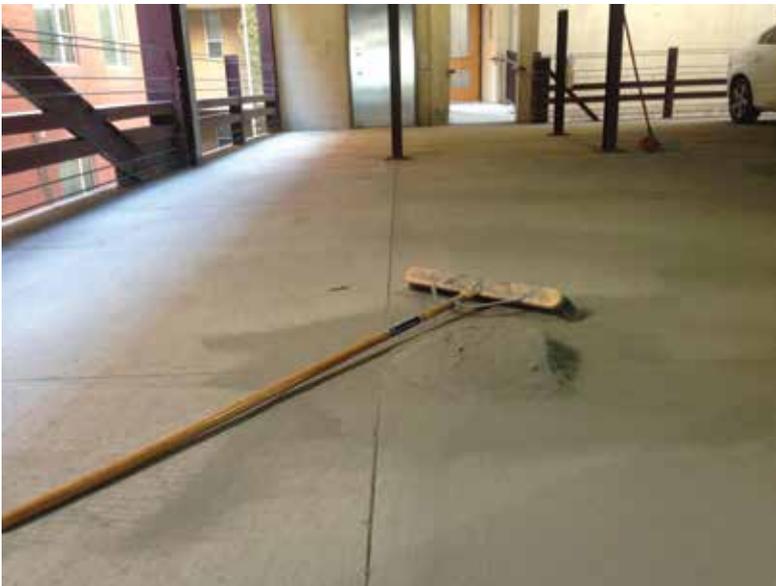
Concrete Dusting

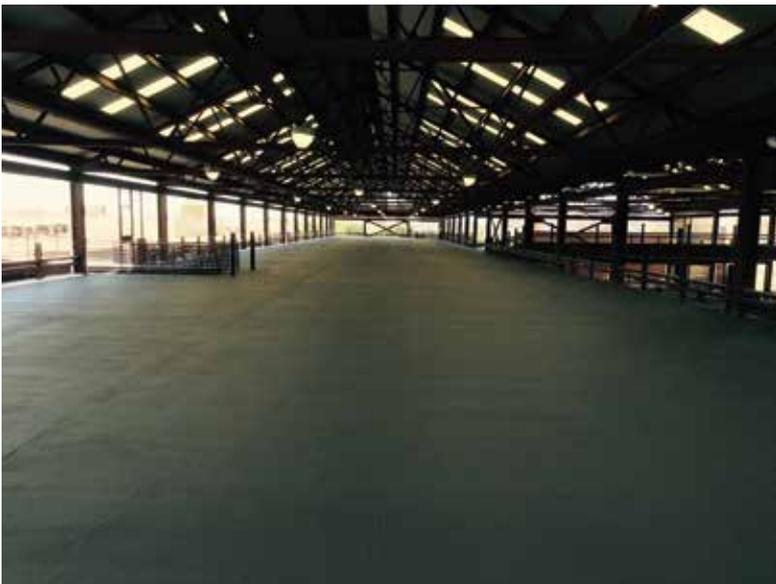
Broadway Lofts Completed Project

Today, some eight months since the completion of the Project (and almost four years since installation of the first on-site test samples), there are no signs of failure of any aspect of the project. For that matter, there are no signs of the repair itself. Broadway Loft's tenants are enjoying a quiet, attractive drive surface on all five garage levels. There is no indication remaining of the damage once thought so severe as to require total deck removal and replacement.
