# The **MIRACOTE**<sup>®</sup> SOLUTION

## MIRACOTE "Pools" Resources at the City of Modesto Centre Plaza Fountain Renovation

**Project:** Water Fountain and Pool Restoration, Modesto, CA  
**Submitted by:** Ron Borum/ Jim Rowe / Miracote  
**Contractor:** Concrete Innovations by Hallack / Julio A. Hallack  
**Products Used:** Membrane A w/Fabric, Miracote MPC and Miraseal

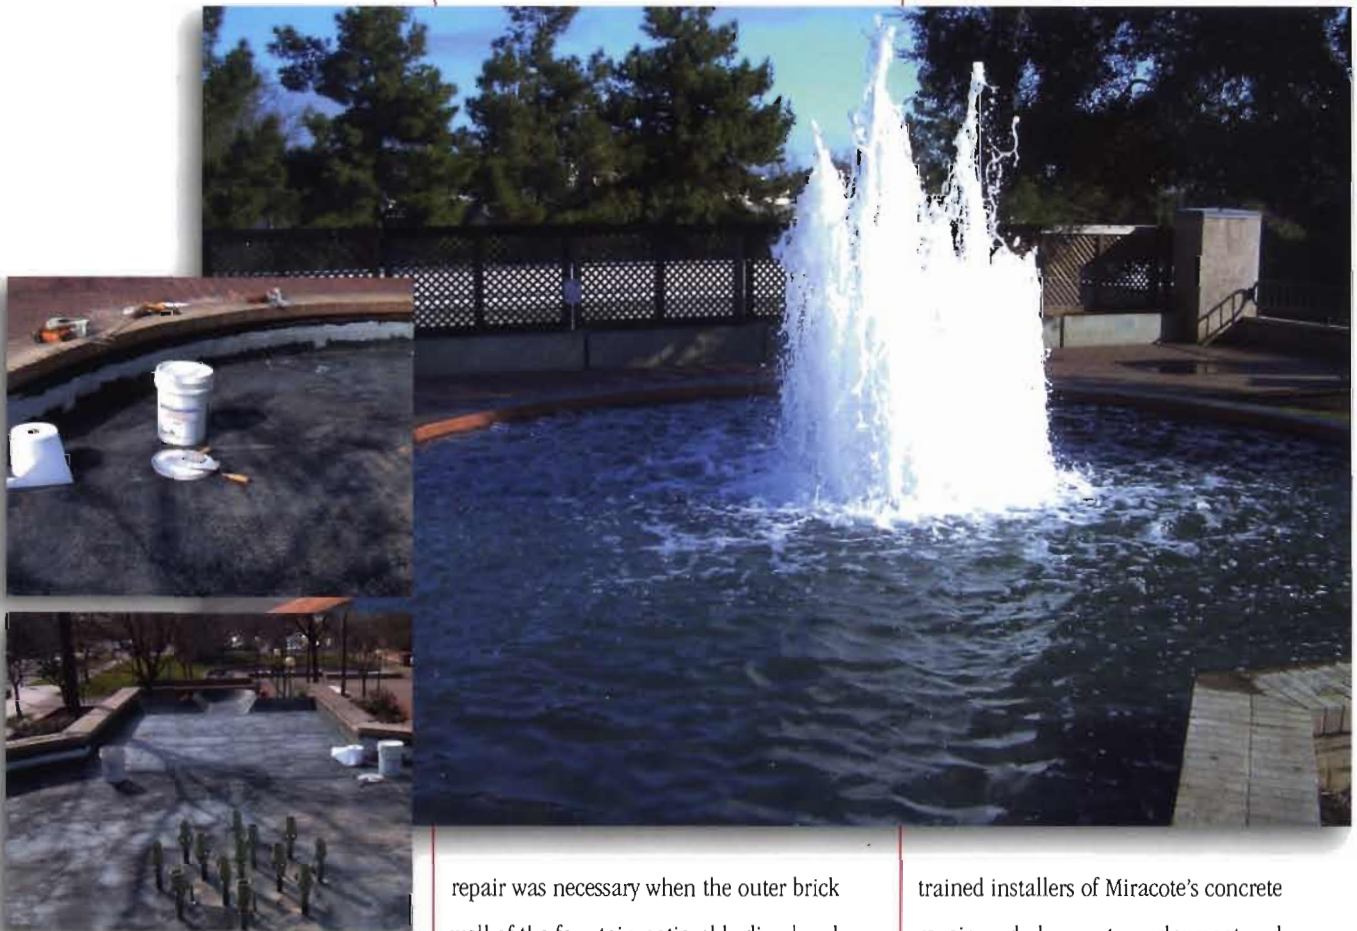
repair was necessary when the outer brick wall of the fountain noticeably discolored due to water leaking and evaporating.

To begin the project, the pool and basin needed to be drained and pressure washed to remove the laitance and other potential contaminants. Once cleaned and dried, the cracks were addressed with a flexible urethane sealant. Next, the entire area was coated with a 25 mil roller application of Miracote's Membrane A, a durable waterproofing membrane. While

still wet, reinforcing fabric was embedded into the Membrane A. This high quality fabric absorbs movement up to 1/16" and enhances the waterproofing benefits of Membrane A. After curing for a few hours, a second lift of Membrane A was applied over the fabric to saturate and encapsulate it, providing maximum flexibility and

waterproofing. The following day, Charcoal Gray Miracote MPC was squeegee applied in three consecutive lifts to achieve a total thickness of 3/32". The MPC polymerized cementitious basecoat filled surface unevenness, rendering a smooth finish ready for the final topcoat. The final day of the project consisted of two roller coat applications of

Miraseal over the MPC. Miraseal is a tough yet economical acrylic sealer that delivers superior UV and abrasion resistance and is ideal for outdoor applications.
